CRITICAL SERVICE BULLETIN

CSB 662A

SUBJECT: TCM D-2000 AND D-3000 SERIES MAGNETO CAPACITORS, P/N'S 10-382807, 10-382681, AND 10-382681-1

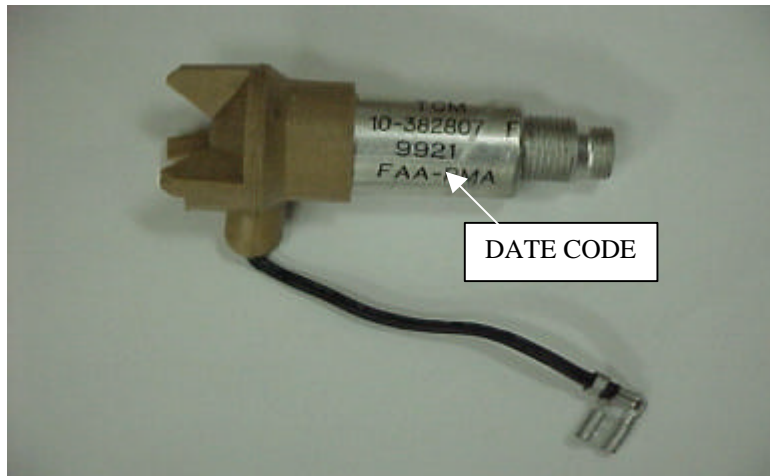
Capacitors are marked with a four-digit date code. The first two digits represent the year (99=1999, 00=2000), and the last two digits represent the week (01= first

week of the year, etc.). Therefore, date code 0001 is newer than date code 9942. See figure 1.

FIGURE 1
Capacitor date code marking.

6. Install new capacitors with date code 9943 or newer, and replace attaching hardware and gasket (if used) in accordance with D-2000 and D-3000 Service Support manual, Form X42003 or later revision, SB651, and SB653.
