**CRITICAL SERVICE BULLETIN**

**CSB 99-3A**

**SUBJECT: CRANKSHAFT INSPECTION**

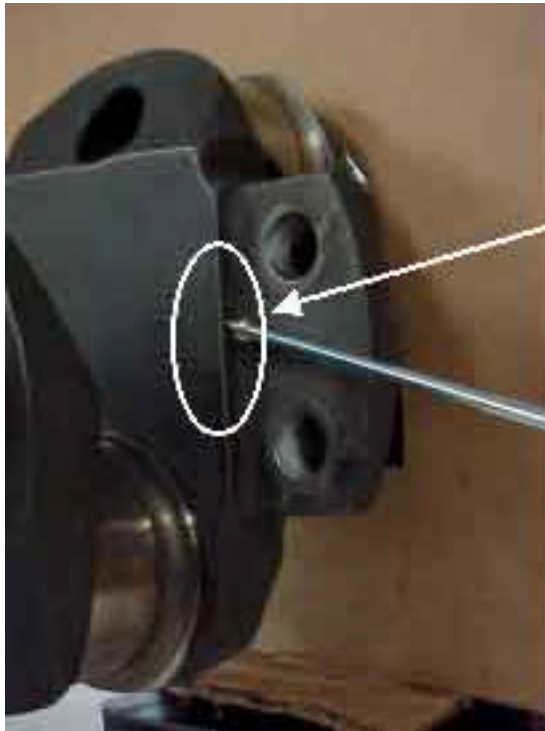
**FIGURE 9. FOCUS INSPECTION IN THIS AREA**

2. Using a flashlight and mirror or a borescope visually inspect the aft side of the number two and five crankshaft cheek for indications of a crack or mechanical damage. The inspection area is between the counterweight blade bushing holes at the chamfered edge of blade shoulder on both sides of the crankshaft cheek. See Figure 10 and Figure 11.
3. If the visual inspection does not clearly reveal a crack, perform an ultrasonic inspection of the aft side of number two and five crankshaft cheek in accordance with Section "B" ULTRASONIC INSPECTION.
4. If visual inspection reveals a crack the engine must be removed from service until repaired or replaced.

Chamfered edge of the aft side of number two and five crankshaft cheek centered between counterweight blade bushing holes on both sides

If a crack or a crack indication is detected during this inspection, the engine must be removed from service until repaired or replaced.

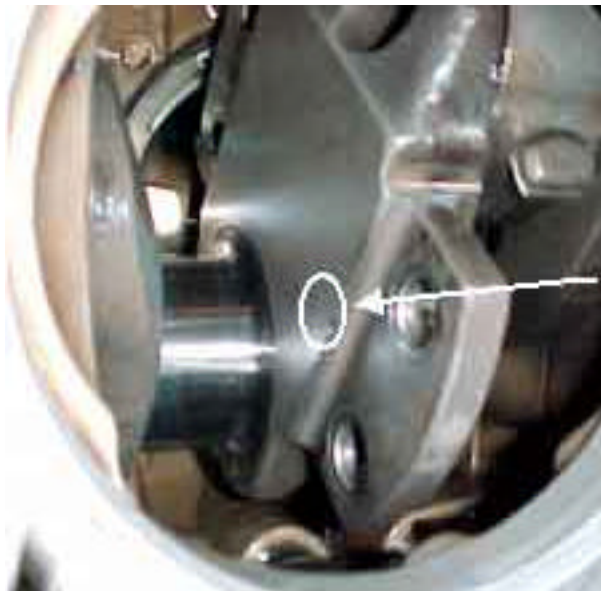
**FIGURE 10. CRANKSHAFT IN INSPECTION POSITION #2 CRANKCHEEK CONNECTING ROD REMOVED**

Inspect area of aft side of cheek between counterweight bushing holes at chamfered edge of blade shoulder on both sides

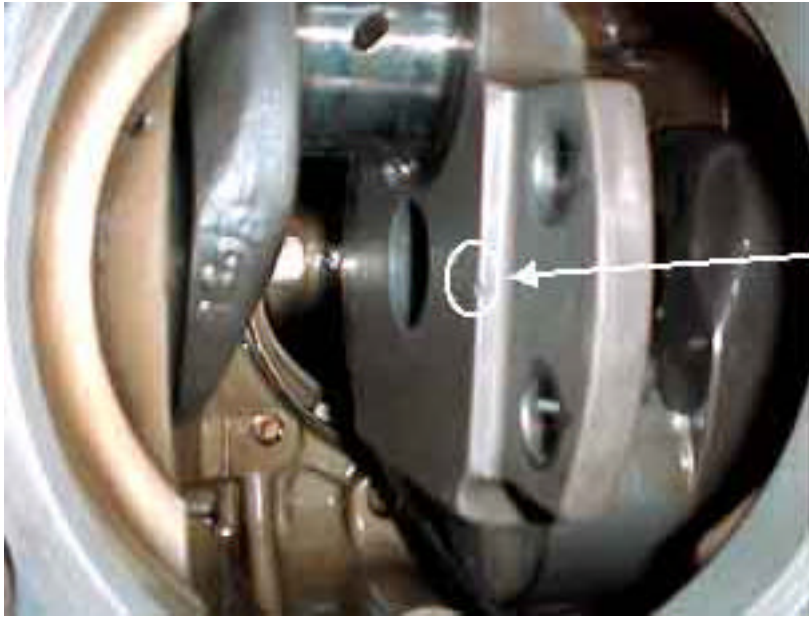
**FIGURE 11. CRANKSHAFT IN INSPECTION POSITION #5 CRANKCHEEK CONNECTING ROD REMOVED**

Inspect area of aft side of cheek between counterweight bushing holes at edge of blade shoulder on both sides
