AERO COMMANDER, INC.

SERVICE LETTER 2002

SERVICE CHANGE 2001 (Formerly Service Letter 2001) October 10, 1966

SERVICE BULLETIN 2001 DATE 8-23-66 REVISIONS None

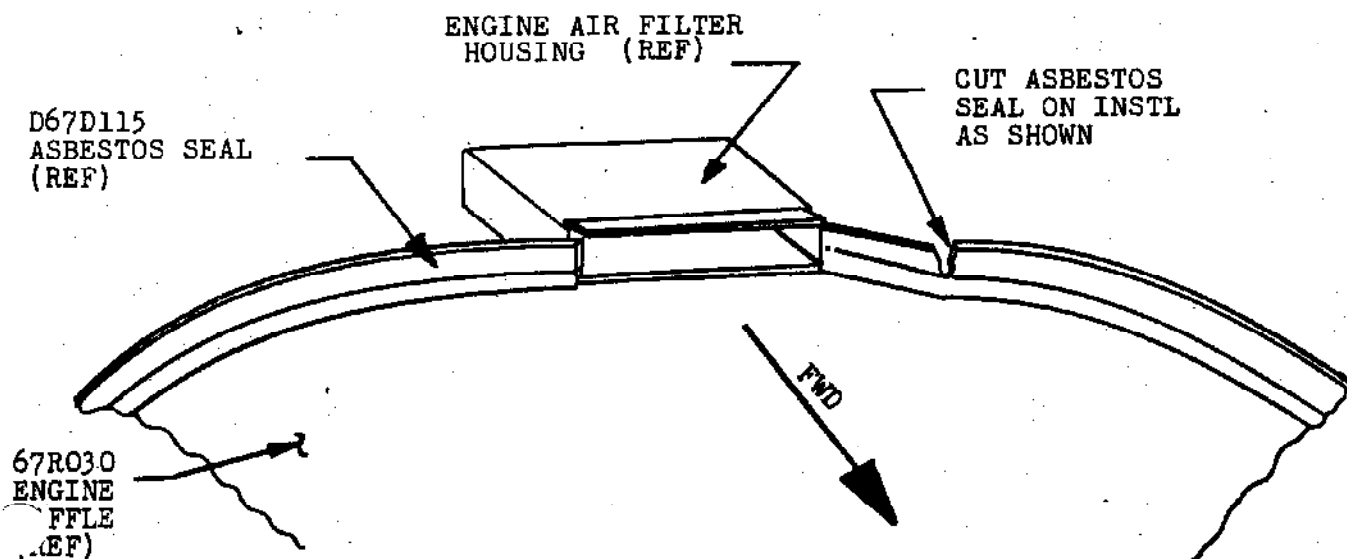
It has come to our attention that it's possible for the asbestos sealing on the engine baffle to be bent in a rearward position in removing and replacing the top engine cowl. This asbestos seal should be bent forward so that the ram air will force it closed and thereby improve engine cooling. To facilitate the forward bend of this asbestos seal, a cut should be made in the seal as per sketch below.

This change should be performed before the next flight. As a precautionary measure, this seal should be checked as part of the pilot pre-flight inspection. This can be easily done by opening the oil dip stick panel and reaching in to feel the seal or by looking through the ram air intake at the front of the airplane and visually noticing the position of the seal.

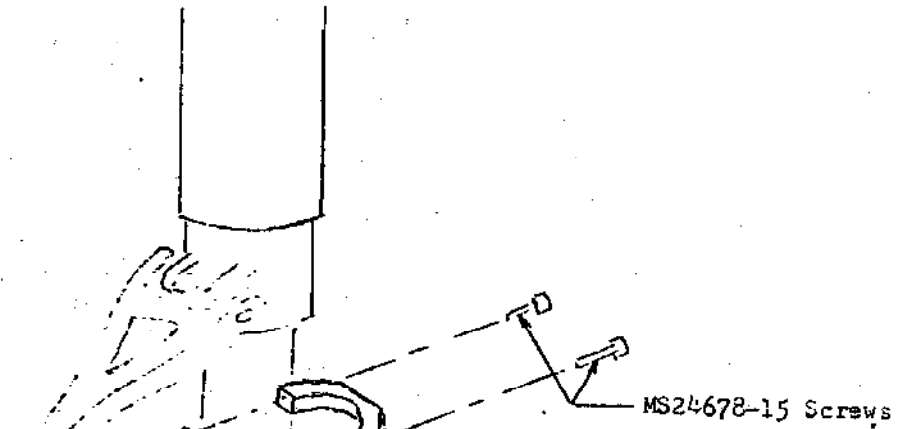
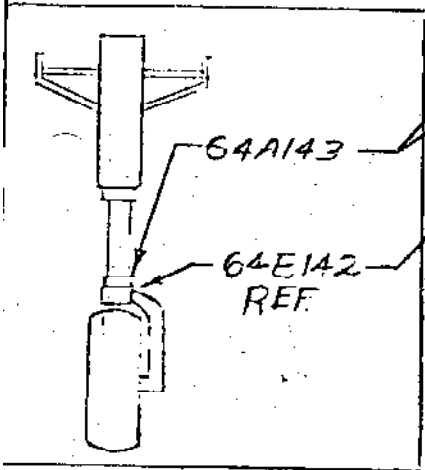
- I. SUBJECT: Landing Gear Improvement
- II. PURPOSE: To provide a positive stop for the nose gear strut. This procedure is to prevent possible internal damage should a hard landing be made with the nose gear strut deflated.
- III. AIRCRAFT EFFECTIVITY: Meyers S/N 251 and up
Aero Commander S/N 301 through 385
- IV. COMPLIANCE: Before next flight.
- V. REFERENCE DATA: Aero Commander Sketch No. SB2003-1
- VI. PROCEDURE: Fit 64A143 stop on the piston rod as shown on Sketch No. SB2003-1.

To prevent the possibility of interference with the nose gear up lock, be sure the 64A143 stop assembly is installed with the flat sides parallel to the nose gear scissors bolts. When screws are tight, safety with lock wire in holes provided.

NOTE: Install the 64A143 stop assy. with the flat sides PARALLEL to the scissors bolts and down against the 64B142 nose wheel casting.

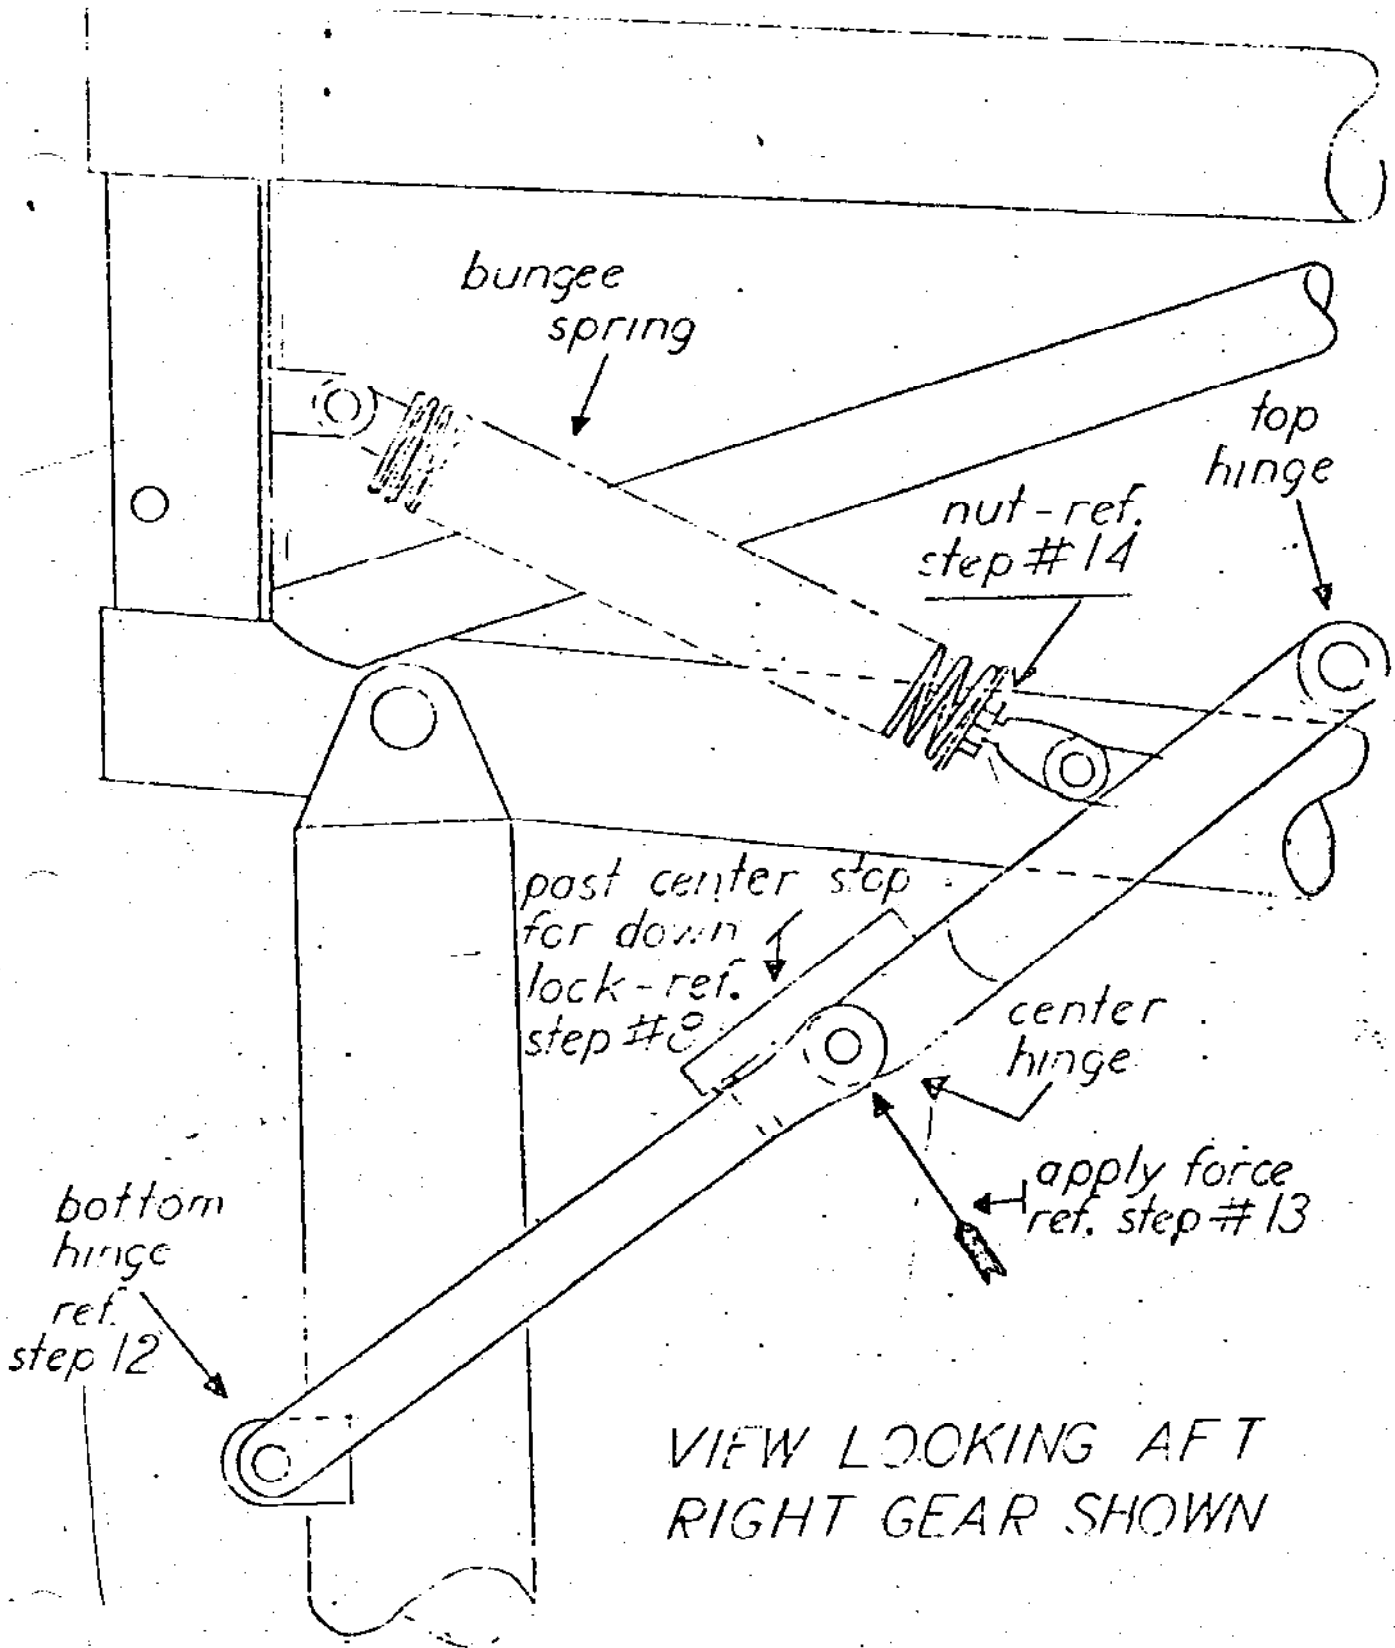
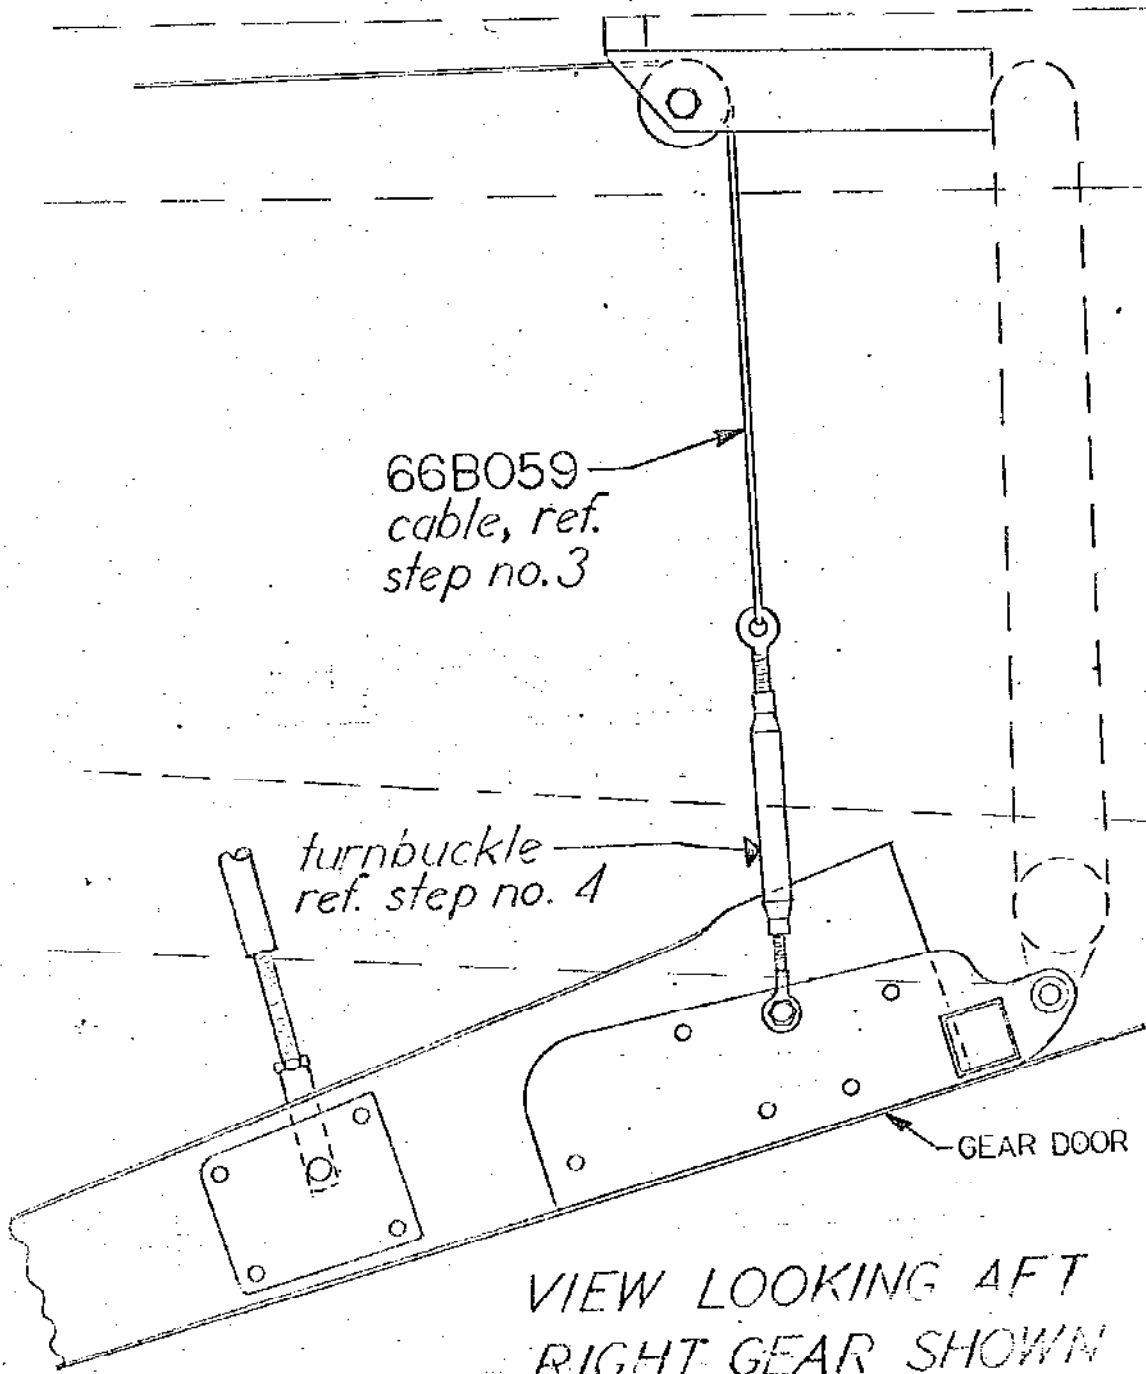
NUMBER
SERIAL 5B 2004-2

66B059
cable, ref.
step no. 3

turnbuckle
ref. step no. 4

3. Check tension on cable number 66B059. (This is the 1/16" cable attached to each main gear that pulls the inside wheel well door closed when the gear is extended.) NOTE: Maximum allowable tension is 60 lbs.

4. If tension on cable 66B059 exceeds 60 lbs., cut safety on turnbuckle and adjust resafety turnbuckle.
 5. Fully retract gear to the up and locked position using the emergency hand pump.

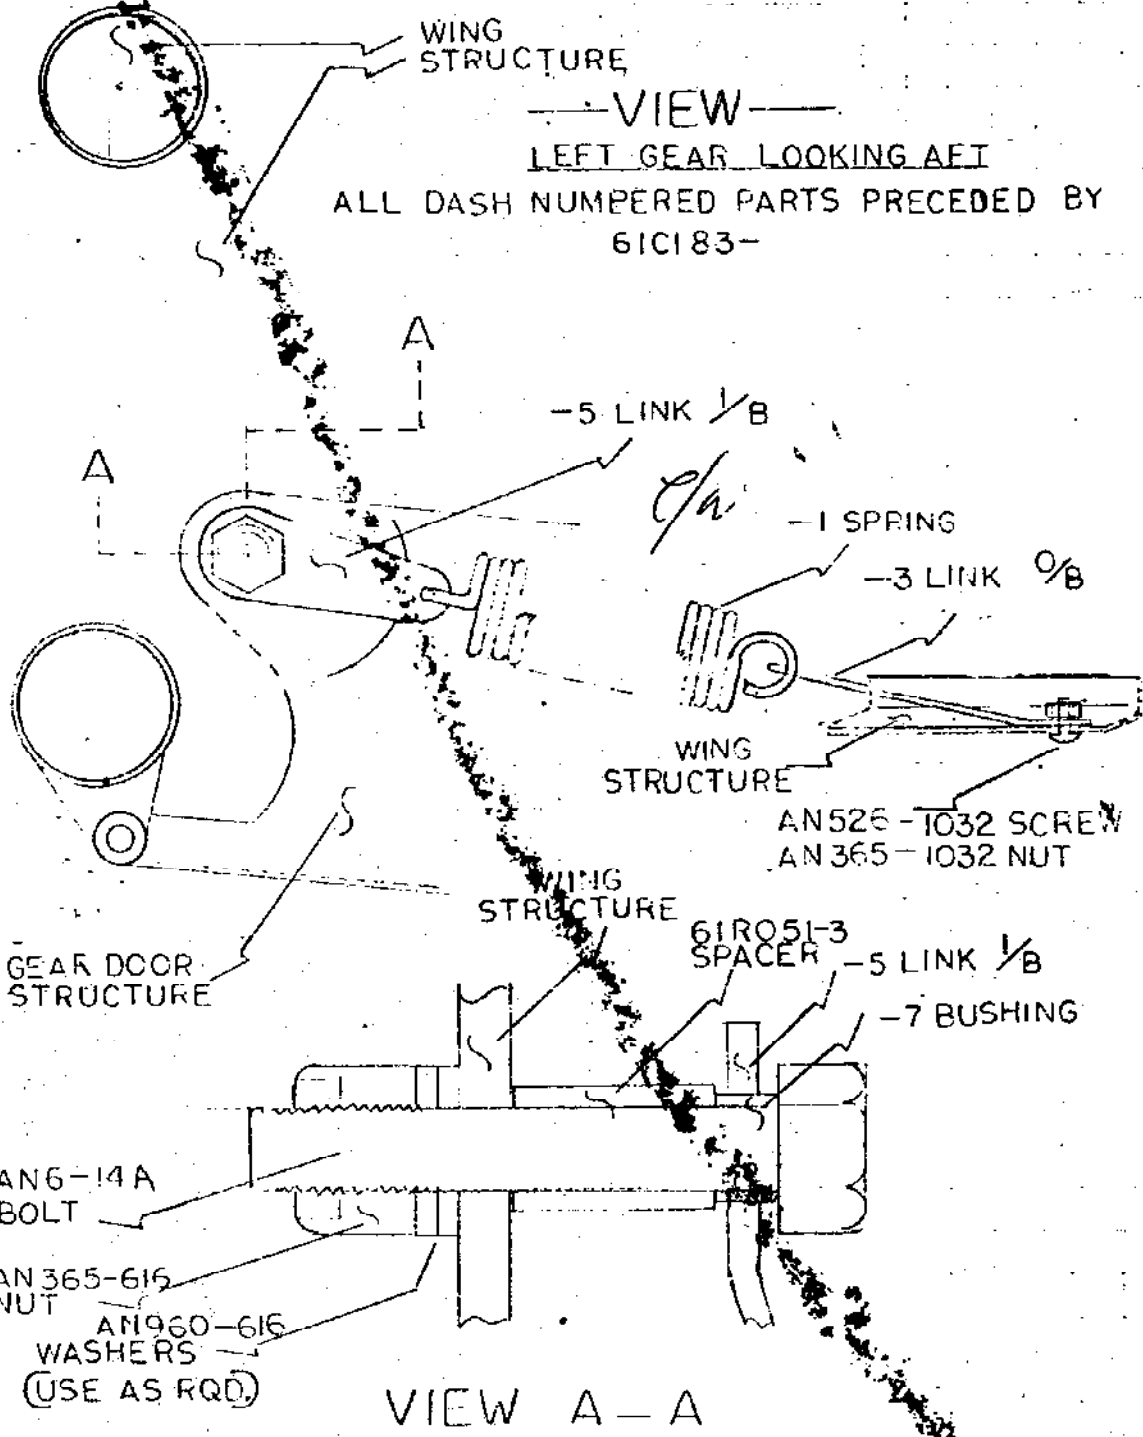
Prepared	NAME <i>R. Stephens</i>	DATE <i>2-18-67</i>	AERO COMMANDER INC. ALBANY, GEORGIA	Page	TEMP.	PERM.
Checked			TITLE SB 2005-1	Model	200	
Approved	<i>R. Stephens</i>	2-18-67		Report No.

- I. SUBJECT: Main Gear Inboard Door Spring
- II. PURPOSE: To increase the service life of the door opening spring.
- III. EFFECTIVITY: Meyers Model 200, Serial #251 to 298, inclusive.
Aero Commander Model 200, Serial #301 to 383, inclusive.
- IV. COMPLIANCE: As soon as possible, but not later than next periodic.
- V. REFERENCE DATA: Aero Commander Drawing SB 2005-1
- VI. PROCEDURE: Install Service Kit SB 2005
 1. Place aircraft on jacks.
 2. Retract gear sufficiently to allow the inboard main gear doors to come fully open.
 3. Remove present springs and all attaching hardware.
 4. Install new springs and attaching hardware as per drawing SB 2005-1.

NOTE: On some earlier aircraft, the hole in the wing may have to be enlarged (#10 drill) to accept the screw attaching the O/B link (61C183-3) to the structure.
