**CRITICAL SERVICE BULLETIN**

**CSB 99-3A**

**SUBJECT: CRANKSHAFT INSPECTION**

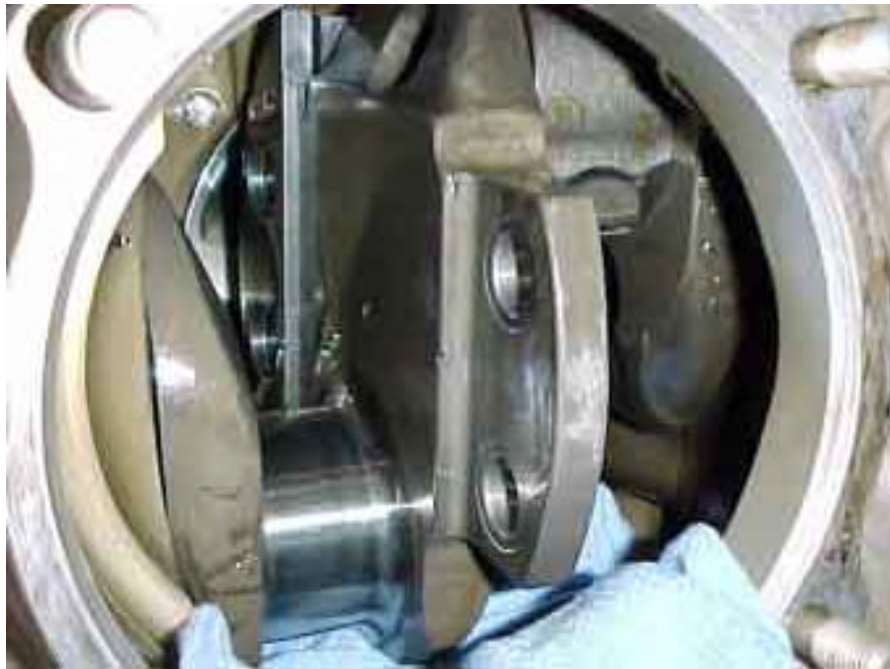
**FIGURE 7. CRANKSHAFT COUNTERWEIGHT BLADE**

2. Using a flashlight and mirror or a borescope visually inspect the aft side of the number two and five crankshaft cheek for indications of a crack or mechanical damage. The inspection area is between the counterweight blade bushing holes at the chamfered edge of blade shoulder on both sides of the crankshaft cheek. See Figure 10 and Figure 11.
3. If the visual inspection does not clearly reveal a crack, perform an ultrasonic inspection of the aft side of number two and five crankshaft cheek in accordance with Section "B" ULTRASONIC INSPECTION.
4. If visual inspection reveals a crack the engine must be removed from service until repaired or replaced.

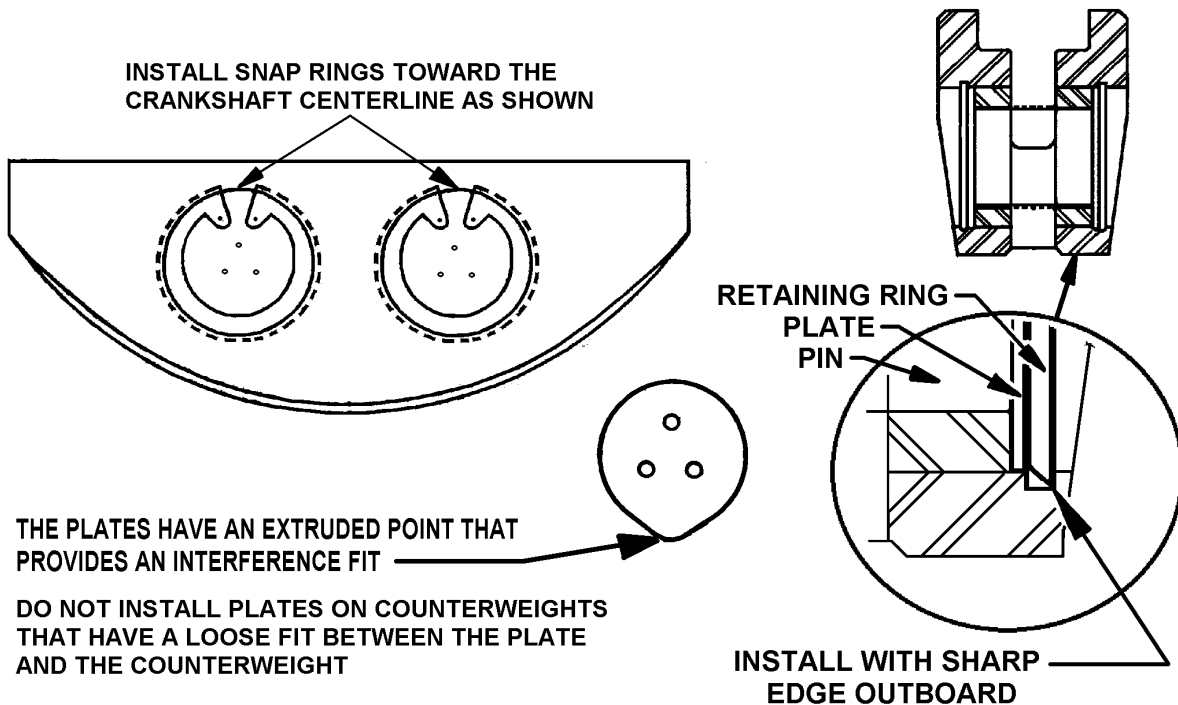
**FIGURE 12. COUNTERWEIGHT INSTALLATION**

**Do not use plates that have a loose fit. Failure to properly install counterweight retaining plates and snap rings may result in engine damage and possible failure.**

*The retaining rings, plates and pins must be installed as shown in Figure 12. "Counterweight Inspection, and Installation."*
